Process Safety Incident of the Week

Waste Water Pit Explosion in Brazil

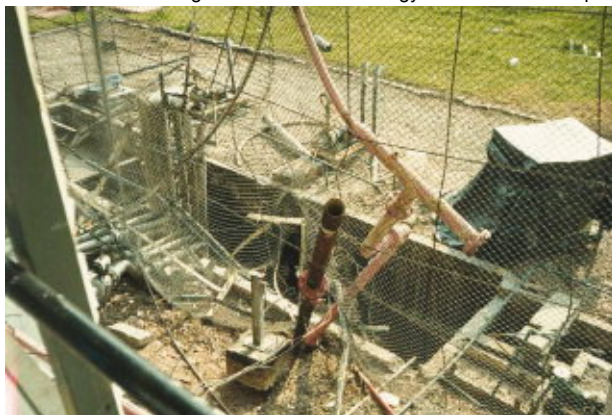
On Sunday, July 26, 1998 at 2:40 AM, an explosion with a shock felt as far as 500 m away occurred in wastewater Pit No. 1 at a chemical plant manufacturing organic peroxides in Brazil. People in the nearby village were awakened and saw a big flash. There were only a few flames from the pit and from some drums around it. The flames were extinguished after 10 min following activation of the fixed fire protection system and action by the facility fire brigade. The main production cell was shut down for 20 days and some plant repairs were needed. Wastewater at the site was initially separated depending on the pH. Acidic wastewater had accumulated in Pit No. 1 from 1 week's production of organic peroxides, primarily methyl ethyl ketone peroxide (MEKP). As Pit No. 1 was not stirred over the weekend, a separation could develop over time with an upper organic layer containing peroxides. The exact initiation mechanism is unknown; however, non-phlegmatized MEKP is known to be extremely unstable. It may be that materials falling into the pit were sufficient to start the decomposition. Otherwise, the hot weather conditions on Saturday may have allowed a decomposition reaction to reach the point of self-accelerating reaction and explosion. There was only 2,000 L of wastewater in the pit, and the pit capacity is $\sim 12 \text{ m}^3$, so the level was low. The confinement effect of the pit walls focused the pressure waves upward and blew off the agitator support grill and angle irons. Damage included blowing out window frames, doorframes, glass, and fan blades. Some corrugated metal panels were deformed, concrete walls on production cells were spalled, and a drill stand was snapped off. Also, the fixed fire protection system was damaged and reduced the ability to passively fight the fire.

The energy released in the explosion was estimated from window breakage to be 16 kg of TNT. Window breakage usually provides the best evidence for setting explosion energy. Analysis of panel deformation on buildings provided 18–23 kg of TNT as a mean with 45 kg TNT as a high value. These estimates agree well with the 7.5–39 kg of TNT available energy estimated from vapor concentration calculations in the pit.

The incident emphasized the need to clarify written procedures and to respond actively to minor events. The significant hazards of non-diluted MEKP were well known to the facility; however, no connection was made between this and the change to remove agitation on the weekends. In fact, there was a warning in this case. On the previous Monday, water from one peroxide batch was sent by mistake to the wrong pit where decomposition occurred. This event was not reported to management as required in local systems. Additionally, for over 20 years, the plant sent all wastewater (after pretreatment) to an off-site facility in a local town. When a required change was made a year earlier to transport effluents away by trailer after neutralization, no clear procedure was written to cover wastewater. One consequence was that responsibilities for waste water and for what happened outside the production cells were not transparent. As a result of the explosion in Pit No. 1, the company built an appropriate safety-training program, renewed internal process safety systems, and strengthened local expertise.
