Process Safety Incident of the Week Tosoh Accident in Japan

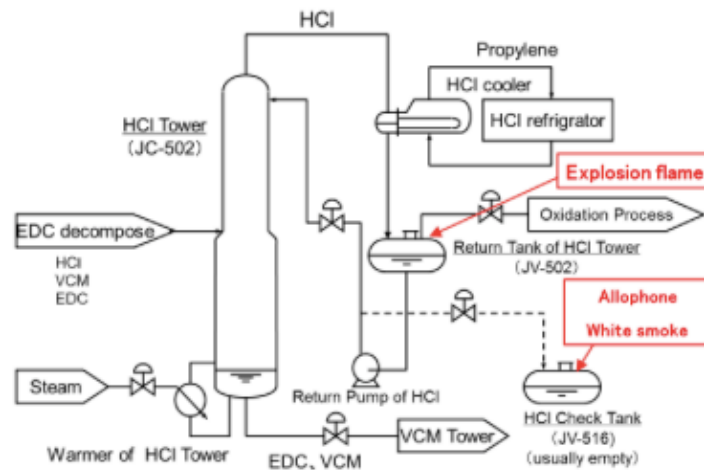
On November 13, 2011, there was an explosion and fire in the HCl tower in Tosoh Corporation in Japan. The ignition started when HCl reacted with VCM to produce 1,1-EDC catalyzed by FeCl_3 , which was produced by HCl and iron rust inside the back-flow tank of the HCl tower. The temperature of the back-flow tank of the HCl was increased and because it is an exothermic reaction, the reaction rate increased exponentially. It all started when the urgent discharge valve for disposal facilities of oxidation line A was broken and the valve suddenly opened during line A operation. An interlock stopped the operation on line A while line B was still operational. Stopped lines A & B of the EDC decomposition process to regulate the production of EDC, which was only produced by line B of the oxidation process. The operating line for the EDC decomposition process changed to line A only changing the operation load from 100% to 45%. The stoppage was partial, the temperature balance of the HCl tower changed and the middle tier temperature fell from 80°C to 57°C. To recover the temperature lost, steam was increased and reflux volume was decreased. The operator did not realize that they should control the top and bottom temperatures of the HCl tower. The temperature at the top of the tower typically is -24°C, but it increased to 38°C. The VCM was mixed in the upper part of the tower and the back-flow tank also. The operators thought the HCl tower condition was stable because the middle stage returned to its normal temperature. After the VCM mixed in the back-flow tank, it then mixed with the oxidation line B causing the entire production facility to stop. The managers realized the temperature at the top of the tower was not normal and assumed the VCM mixed into the back-flow tank, but were unaware of the 1,1-EDC that was generated. They stopped the back-flow pump, which brought the level of HCl in this tank back to 100% and then sealed it. The HCl tower refrigerator was stopped and the back flow tank of the HCl tower was disconnected from the main tower, so the backflow tank of the HCl tower was sealed. The transfer of liquid from the back-flow tank of the HCl tower to the liquid HCl temporary receiving tank started and the pressure of the liquid HCl in the temporary tank began to increase, something the operators were unaware of.

They soon realized the pressure increase in the temporary tank and they started pressure relief action. The allophone sounded and white smoke discharged from the top of the liquid HCl temporary tank during the relief. The pressure of the back-flow tank of the HCl tower rose to 2.0 MPaG and it can hold only a pressure of 1.9 MPaG. This pressure caused the tank to rupture, explode and burst into flames.

First thing is the lack of training for the operator when he was restoring temperature to only the middle stage. It is necessary to take both the top and bottom into consideration also when increasing temperature anywhere and this was something the operator was unaware of due to gaps in his training. There was also no alarm for detecting abnormal temperatures at the top of the tower, which caused the operator to be only focused on the middle tier to be monitored. There was also a lack of written record saying the standard value of temperature of each part of the HCl tower. This plant lacked any operating standards, which did not help operators safely solve their problems.
