Process Safety Incident of the Week

Deadly Chemical Explosion at BASF

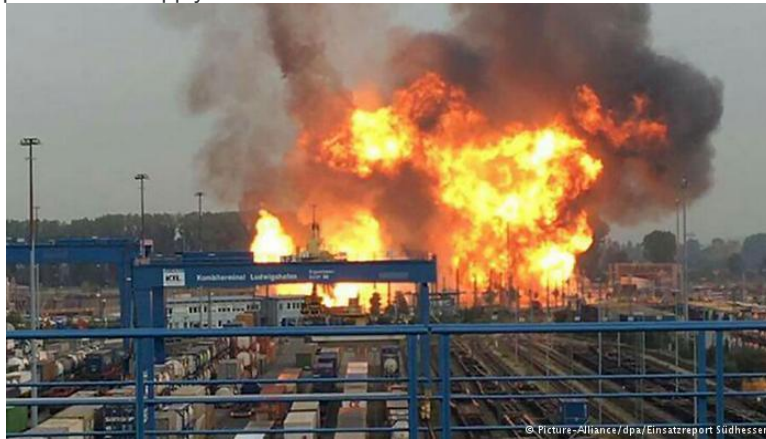
At BASF's Germany site in Ludwigshafen, a huge chemical explosion occurred killing three people and injured about 20 others. The explosion and the fire happened along the pipelines that connect BASF's harbor to the Rhine River. Maintenance was being done on the pipelines, which carried ethylene and propylene. It started with a fire on Monday October 17, 2016, around 11:30am. The emergency response team immediately responded and started to perform emergency operations. During the initiation of the safety measures, an explosion occurred. It took firefighters 10 hours to extinguish the fire. The explosion caused BASF to shut down 20 facilities. The explosion led to multiple fires at multiple points down the pipeline, damaging further product and supply lines.

After further investigation of the cause of the explosion, it was concluded that the source of ignition came from a cut in a nearby pipeline that contained flammable gases. A contractor cutting the wrong pipeline caused it. It is proposed the flammable gas leaked out and ignited due to the sparks produced from the grinding of pipelines going on around it. This mistake is something that could be prevented by properly planning maintenance work ahead and consulting other BASF employees before starting the work. There were also multiple pipelines making it more difficult to ensure the correct line was being cut. We learn how important the idea of line labeling is in order to be able to distinguish the correct pipe that should be getting work done on which can prevent any possible mistakes.
