Process Safety Incident of the Week Hoeganaes Combustible Dust Flash Fires

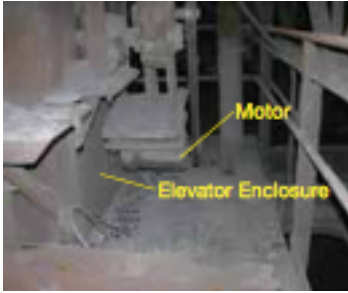
In 2011, a series of iron dust flash fires and hydrogen explosions happened in the Hoeganaes facility in Gallatin, TN. This plant specialized in melting and converting scrap metal to various metal powders. There were three separate incidents. The first accident happened on January 31, 2011, the operators thought that the belt on the bucket elevator was off its track. They shut down the motor, and maintenance and an electrician inspected the equipment. They did not think the belt was off the track and told the operator to restart the motor. When the motor restarted, the powder from the equipment and floor dispersed causing a flash fire almost immediately and engulfed the two workers, killing both.

Understanding hazards and risks is one of the pillars of PSM. After the incidents, combustibility tests indicated that the iron dust was a weak explosion hazard and relatively hard to ignite. These findings were similar to an audit performed in 2008. A lesson is that even a weak explosive and hard to ignite dust it is still combustible and should still be considered hazardous and capable of causing fatalities when ignited. The personnel at this facility did not fully comprehend the full risk of the dust. Another pillar of PSM is learning from experience. In 1992 the plant had a very similar incident to the third incident in 2011. Another employee was burned from a hydrogen explosion in the furnace. Hoeganaes did not learn from its own incident. Housekeeping is also extremely important in a facility that handles solids. All three of these incidents occurred due to large quantities of combustible dust present. At this facility, there was poor housekeeping and had no control of dust emissions. The ineffective dust control and housekeeping enabled dust layers with more than enough dust to fuel these three flash fires. The lack of housekeeping and dust control were all contributing factors to the incidents.

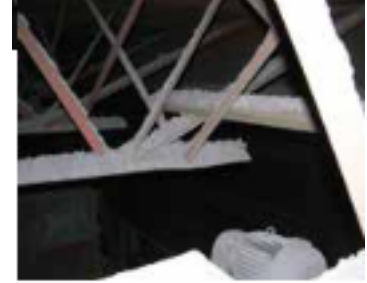
The second incident occurred on March 29, 2011 when a facility engineer and contractor were replacing the igniters on an annealing furnace. There was difficulty reconnecting a gas line and the engineer used a hammer to force the connection. Large amounts of dust on nearby surfaces were dispersed by the force of the hammer and ignited almost immediately. The engineer suffered first and second degree burns, while the contractor was able to escape. The engineer was wearing flame-resistant clothing, which helped prevent worse burns.
